DEPARTMENT OF NATURAL RESOURCES

Division of Oil, Gas and Mining

Minerals Inspection Report

Mine Name: La Sal #2	Permit Number: S/037/0125	Mine Status: Inactive
Operator Name: Laramide La Sal, Inc.	Inspection Date: 08/26/2014	Permit Fees: Paid
Inspector(s): M. Bradley	Inspection Time: 2:30pm	Bond Amount: \$69,323
Attendee(s): Doug Rowles, BLM	Weather: Cloudy, warm	Bond Escalation: 08/23/2017
Inspection Purpose: Routine inspection		Prior Inspection: 07/24/2013

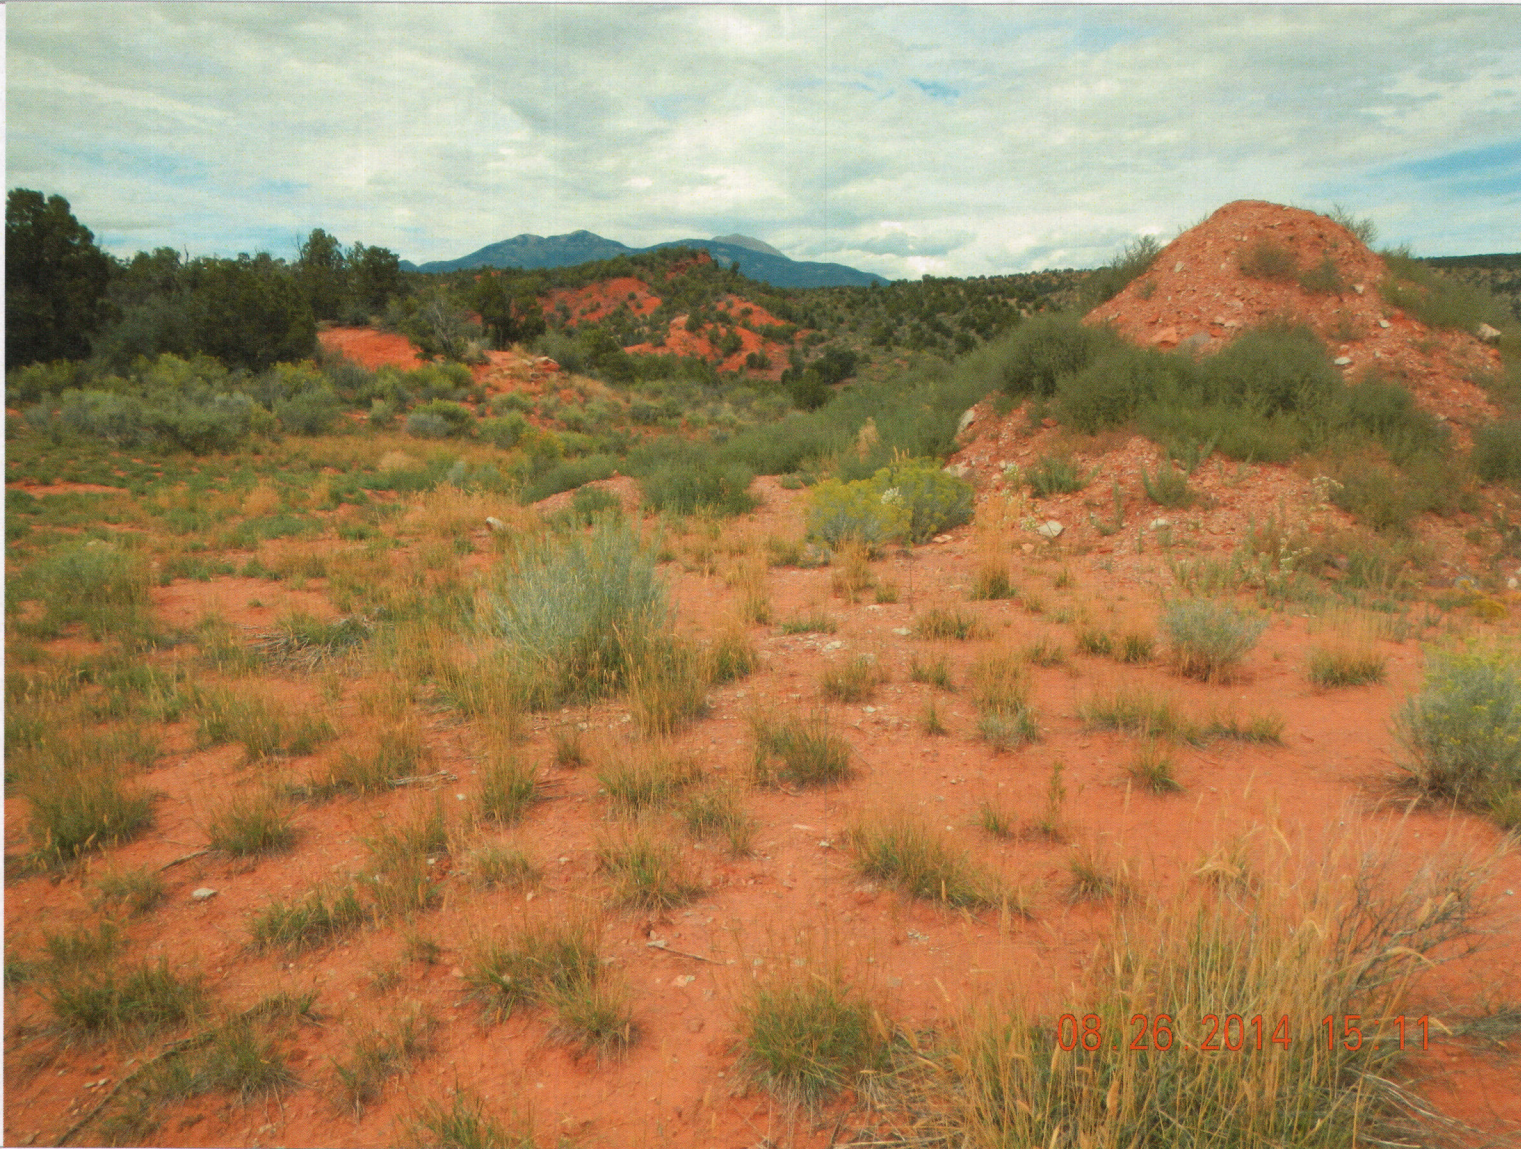
8. <i>Soils</i>	<input type="checkbox"/>	<input type="checkbox"/>
9. <i>Revegetation</i>	<input checked="" type="checkbox"/>	<input type="checkbox"/>
Checked for presence of knapweed after operator stated they had been removed/eradicated. Inspection confirmed no knapweed currently present.

Area immediately west of topsoil stockpile where knapweed was located. No evidence of knapweed now.

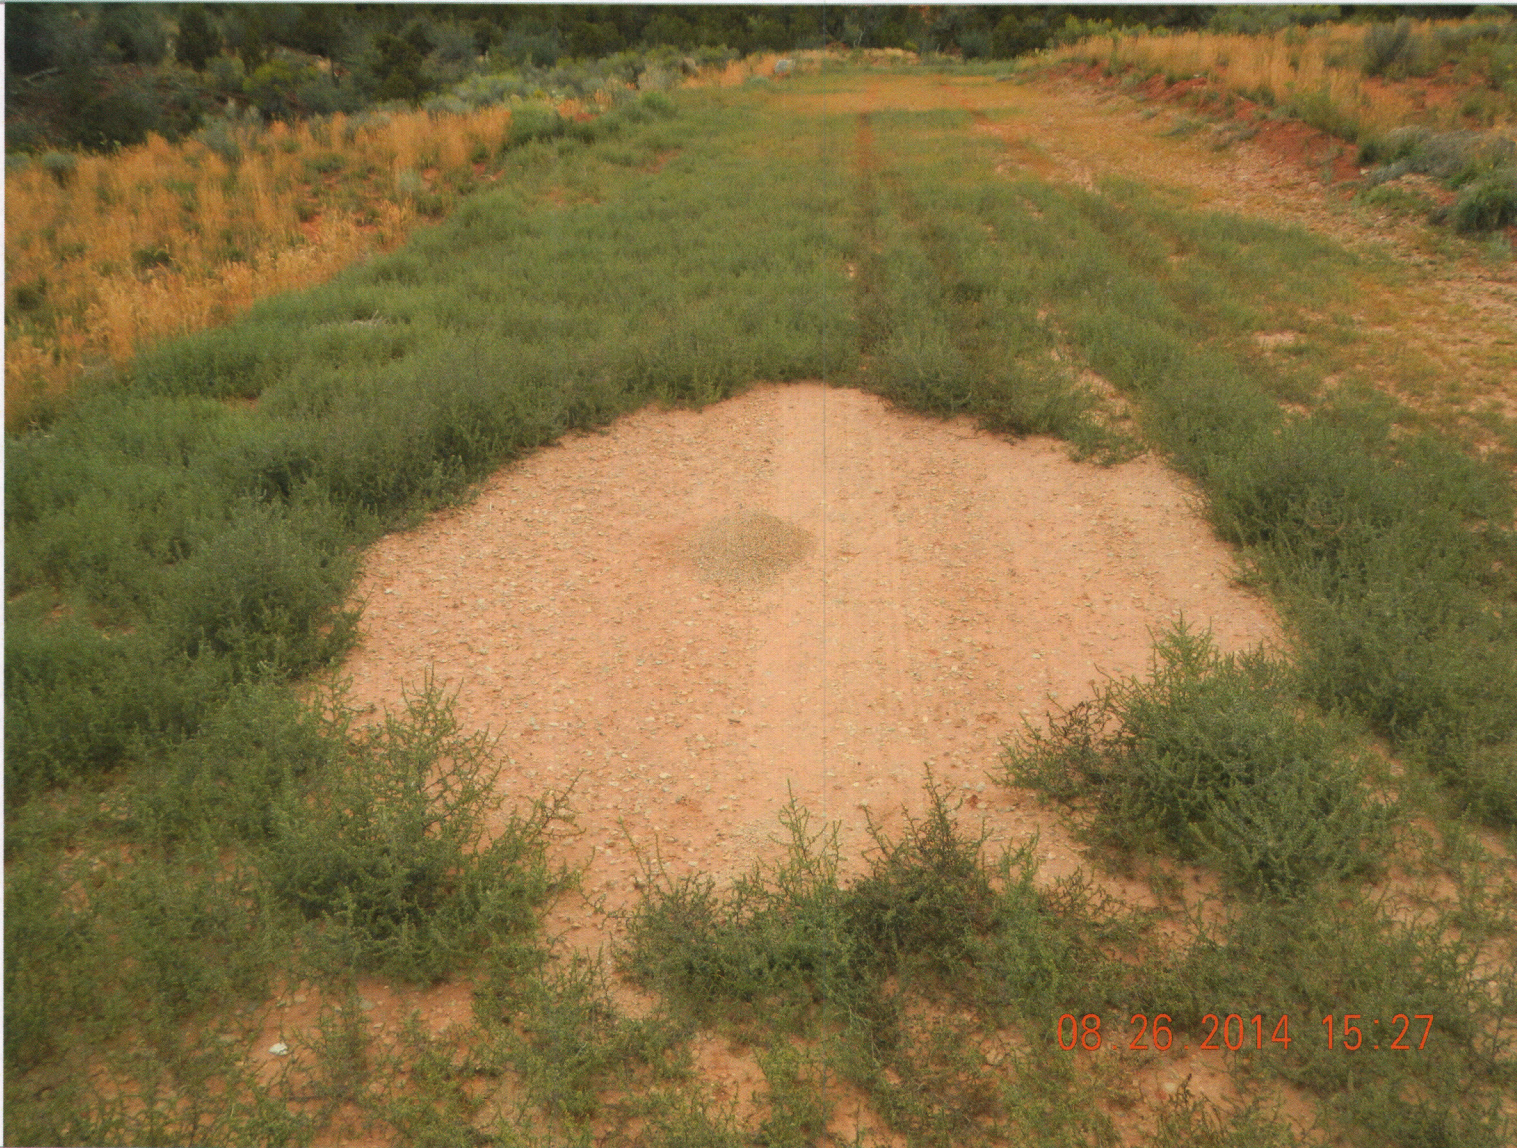
5. <i>Roads (maintenance, surfacing, dust control, safety)</i>	<input checked="" type="checkbox"/>	<input type="checkbox"/>
Road into site inside the locked gate is covered with Russian thistle.

Road into site covered with Russian thistle, except where this harvester ant colony has cleared the vegetation away from around the nest entrance.
